# **International Forestry**

**TREE PLAN FOR  
12626 NE 105<sup>th</sup> PL  
Kirkland, WA**

**PARCELS #6743700315**

**December 7<sup>th</sup>, 2010**

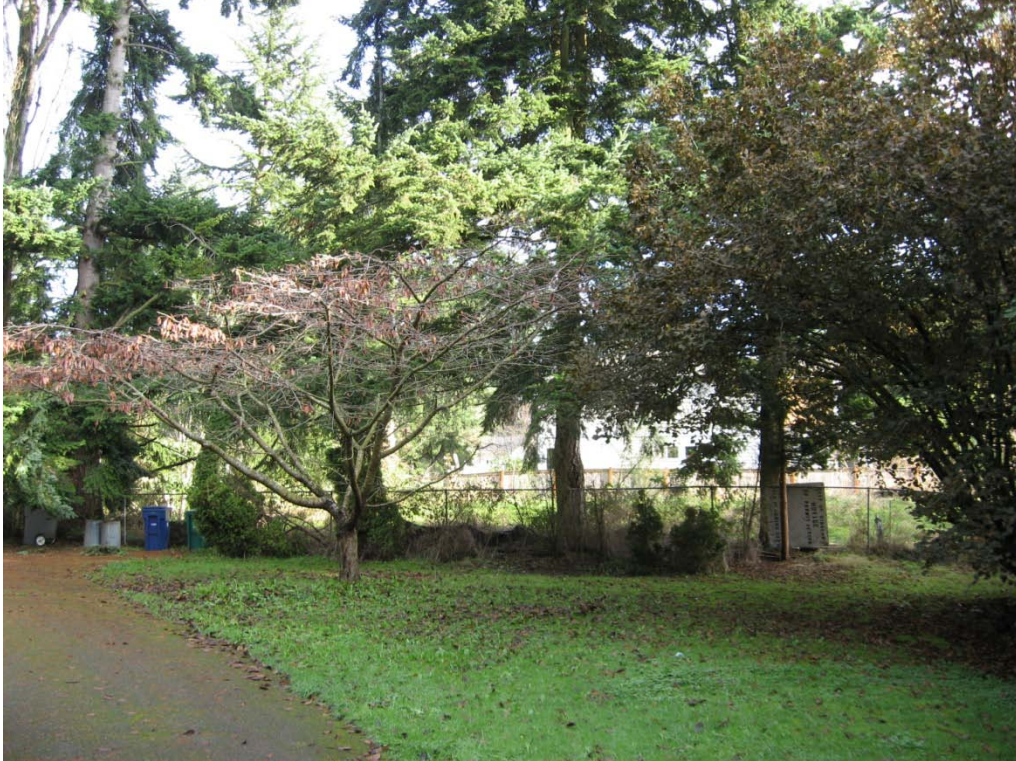
Tree #101 is a mature flowering cherry. The diameter was measured at one foot above ground, because the main trunk forks below DBH into multiple scaffolds. No concerning defects were observed. Vigor appears good.

Tree #101, with neighboring trees #201 > #204 in background, large shrub on right is a beaked hazelnut

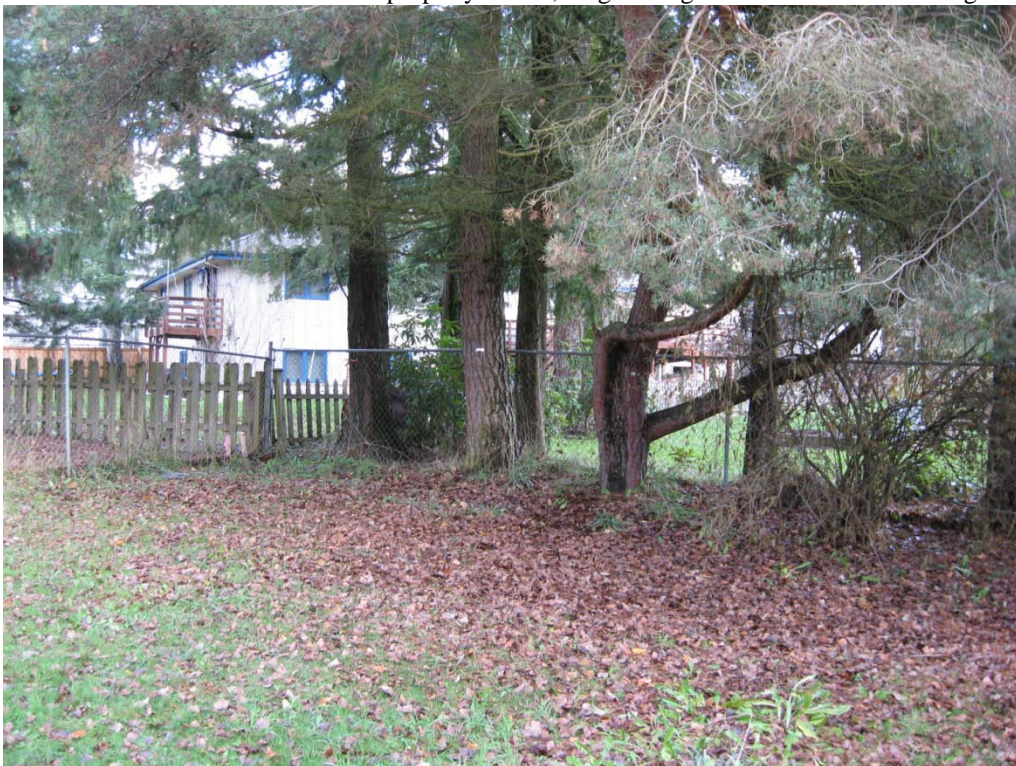
Tree #103 is a semi-mature to mature Scots pine, also situated close to the east property line. It also leans southwest away from neighboring poplar trees. The lower trunk has excessive sweep but is not considered a major defect. Overall condition is fair.

Tree #104 is a young to semi-mature Douglas-fir, also situated near the east property line, close to the northeast corner. Vigor appears good. The main central leader appears to have broken out of the tree in a recent windstorm. Foliage is of good color and density. No major defects were observed.

Trees #103 and #104 near northeast property corner, neighboring trees #215>#217 in background

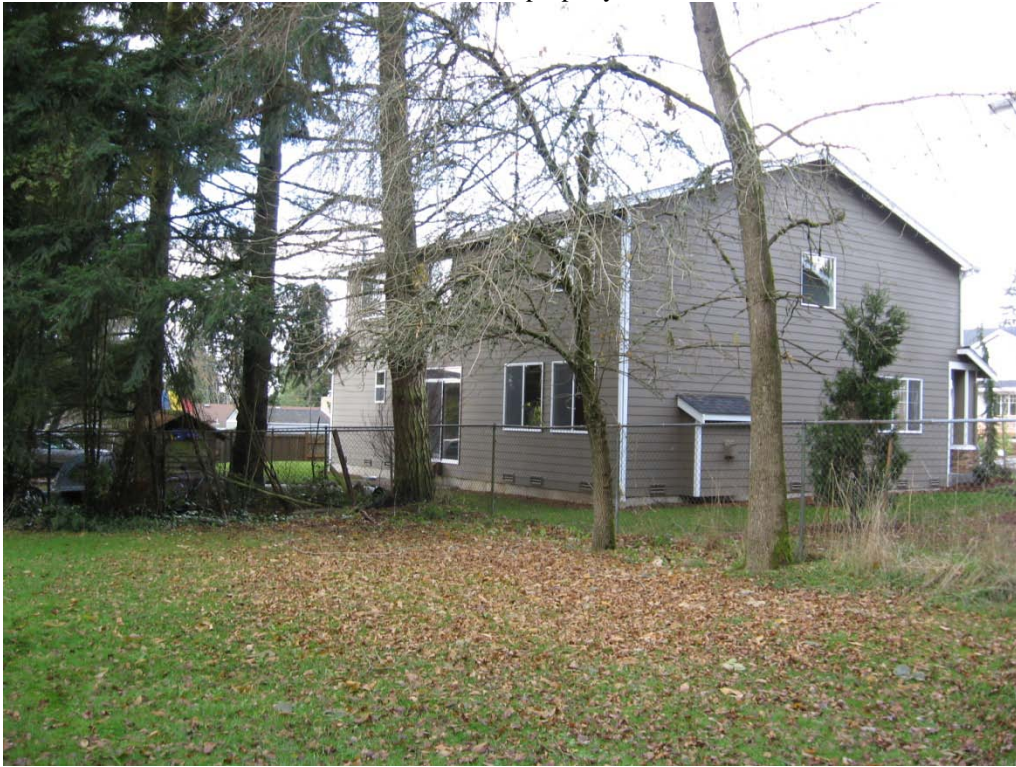
Trees #105 and #106 are semi-mature green ash trees, situated close to the north property line. Tree #105 is in good condition, with typical form or architecture. No noteworthy defects were observed. Tree #106 is suppressed by trees #105 and #107, and has developed poor branch structure as a result. Portions of the top have broken out in the past. Crown cleaning is recommended to improve branch structure. Overall condition is fair.

Trees #107, #108, #109, #110 and #111 are semi-mature Douglas-firs. All are of similar age and size, likely planted at the same time. Foliage color and density is excellent, with full crowns. #107, #108 and #111 have been recently crown raised, mainly on their north sides by the adjoining property owner. The trunk of tree #110 forks into codominant stems at approximately 20' above ground. Significant included or embedded bark is visible from the ground. Isolating this tree may cause it to fail; it should only be retained as a part of a grouping.

Trees #105, #106, #107, #108 and #111 on north property line

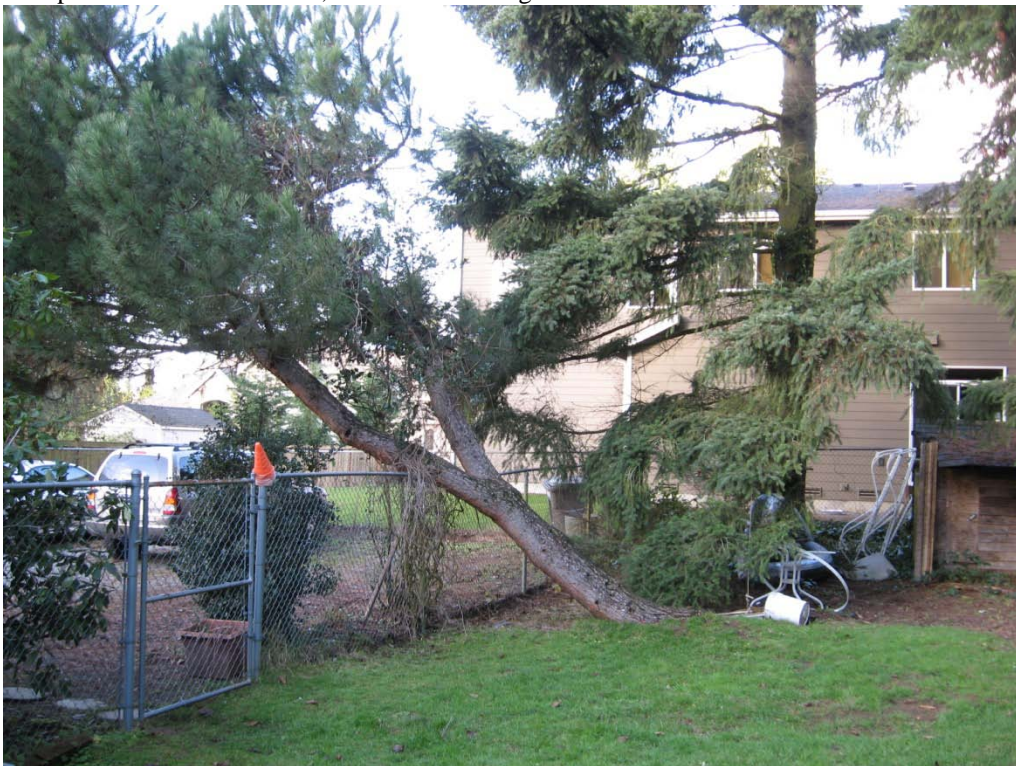
Trees #112 is a semi-mature to mature Austrian pine. The root plate has shifted in the past, causing the tree to lean heavily to the west, resting on the fence. This has compromised stability and cannot be corrected. It is considered non-viable.

Root plate failure of tree #112, tree #111 in background

| Tree/Tag # | Species | Native/<br>Planted/<br>Volunteer | DBH | Height | Tree<br>Credit | Drip-Line/Limits of Disturbance (feet) | | | | Condition | Viability | Comments |
|---|---|---|---|---|---|--|---|---|---|---|---|---|
| 112 | Austrian pine | P | 14 | 22 | na | 0/na | 12/na | 0/na | 20/na | poor | non | root plate failure, leans on fence |

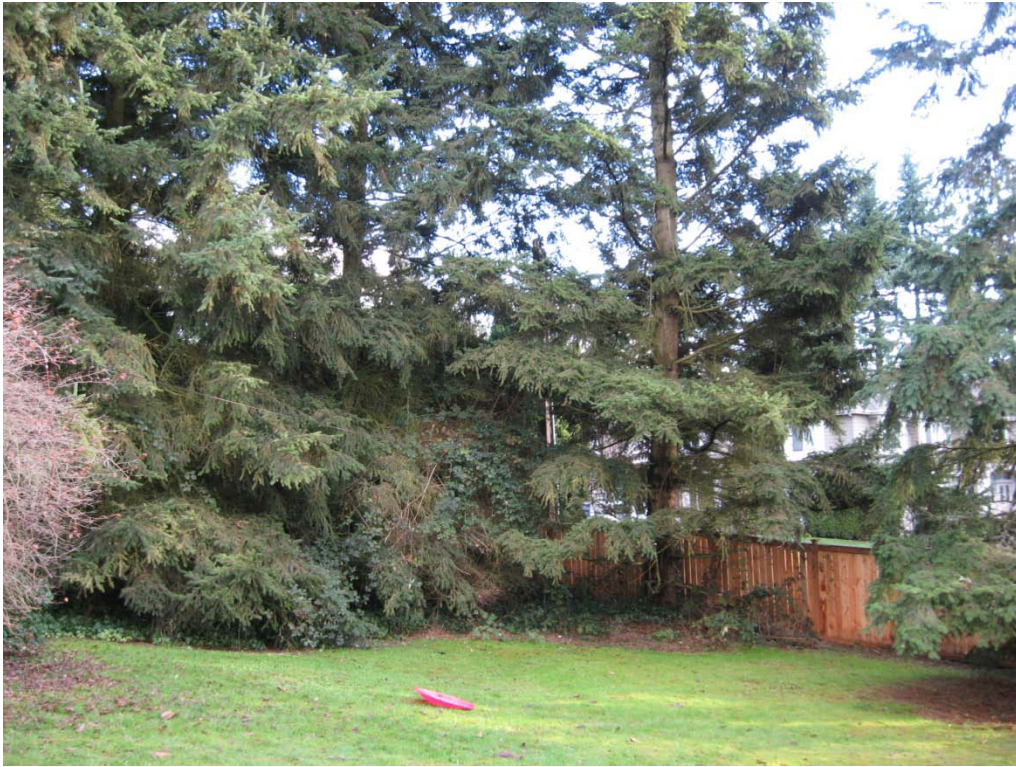
Trees #115 and #116 are attached at the base, where they fork from a single trunk at 2' above ground. The buildup of included or embedded bark between these two trees is significant. Tree #117 also forks into codominant stems at approximately 16' above ground. Trees #115, #116 and #117 cannot be isolated. They should only be retained as a large grouping. Tree #121 has developed poor form or architecture, attributable to competition for sunlight with the adjacent cherry cluster. The main trunk has several minor to moderate structural defects. Failure risk is low, overall condition is fair at best.

Trees #117, #118 and #119 in south end of lots

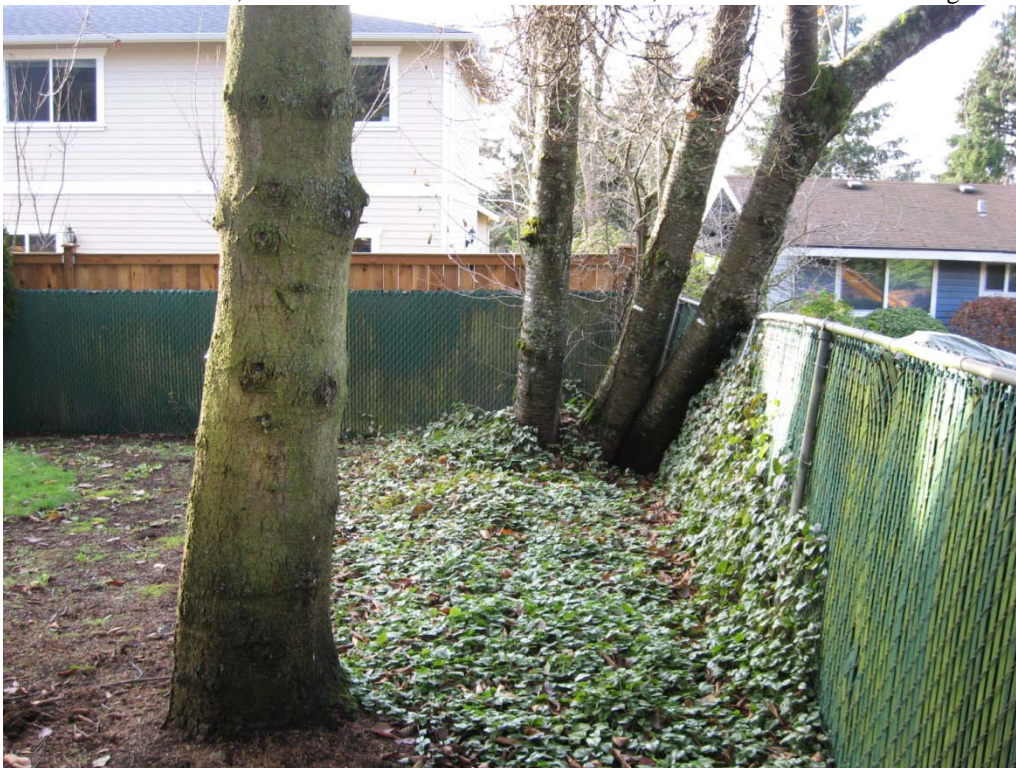
Trees #122, #123 and #124 are mature bitter cherry, *Prunus emarginata*. This is a native, pioneer species. Tree #122 leans to the north over the adjacent property. Tree #123 also leans north. Over 90% of this tree is over the neighboring property to the north. Tree #124 has two large cavities on the southwest side of the trunk, where significant stem decay is visible. This decay appears to be associated with sunscald or an past injury.

The entire cluster is in fair to poor condition, due to defects, leans and age. The subject cluster is a liability. Tree parts will most likely fall into the neighbor's property when upper crown components fail. The cluster is mature, and not expected to survive for more than another decade.

Tree #121 in forefront, Trees #122>#124 in northwest corner, most of tree leans over neighboring property

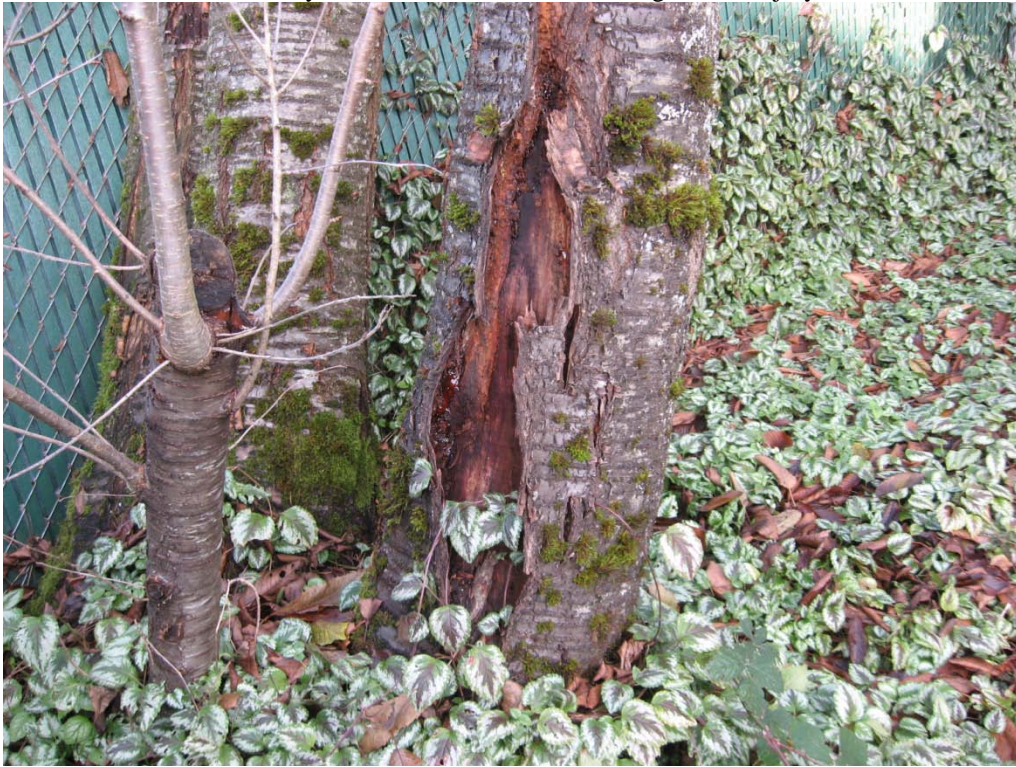
Base of tree #124, stem decay associated with sunscald damage or old injury

| Tree/Tag # | Species | Native/<br>Planted/<br>Volunteer | DBH | Height | Tree<br>Credit | Drip-Line/Limits of Disturbance (feet) | | | | Condition | Viability | Comments |
|---|---|---|---|---|---|--|---|---|---|---|---|---|
| 124 | bitter cherry | N | 13 | 48 | na | na | 18/na | 12/na | na | poor | non | significant stem decay, high risk |

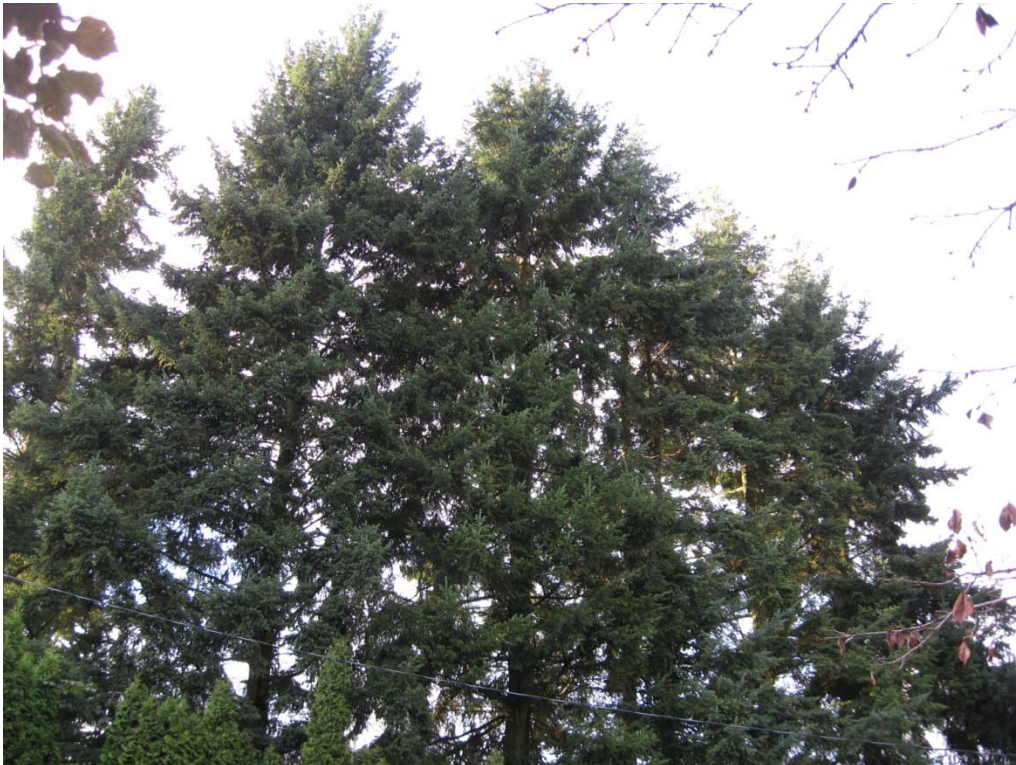
Trees #113 through #121 are semi-mature Douglas-firs. All are of similar age and size, planted at the same time. Foliage color and density is excellent. Most have developed good trunk taper with full crowns. Trees #113, #114, #118, #119 and #120 are in good condition with no concerning defects.

Crowns of trees #113 > #120
